IMPACT ANALYSIS OF THE DAMAGE VEHICLE FINDINGS AND OPINION EXPERTS INFURNISHED TRAFFIC ACCIDENTS

Doc.dr. sc. Tihomir Đurić, email: mrdjtih@teol.net
Prof. dr. sc. Sinan Alispahić, email: sinan.alispahic@iu-travnik.com

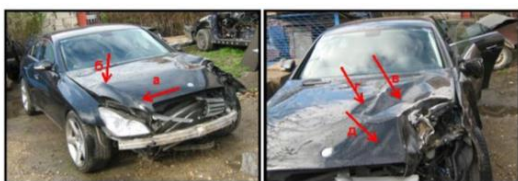
Figure 1. Width appearance of engine bonnet damage [3]

Figure 2. Engine bonnet damage display [3]

A detailed analysis of the submitted photographs from photo documentation found that the bonnet of the engine compartment MERCEDESA in the right front part was deformed by the action of a force in different directions and directions with a center of impact in several different places, figure 1. The damage to the front left part of the bonnet of the engine compartment is in the form of deformations sheet by the action of forces in different directions and directions, with a center of impact in several different places, Figure 2.

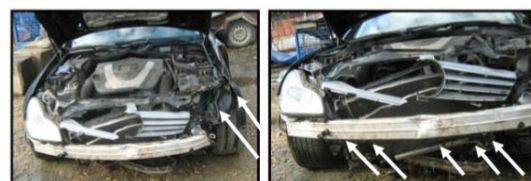
The front decorative mask MERCEDES is broken and most of the right part of the front decorative mask is missing. The front bumper's front tire is damaged by the left corner being deformed by a force acting in the direction from the front left corridor to the rear right corner of the MERCEDES and is moved upwards, while at the height of the center of the forehead part of the MERCEDES, it is deformed by the action of the force, approximately from the upper to the lower part of MERCEDES, figure 3. Damage to the engine coolant cooler and the MERCEDES air conditioner cooler is located out of its tray and are moved downwards. On the lower part of the coolant radiator and the air conditioner cooling radiators, they are in the form of a deformation of the sheet by displacing it backwards by acting force in the direction from the front to the rear of the MERCEDESA, fig. 4.

Figure 3. Display of the damage of the upper left-hand cooler "connecting bracket" [3]

Figure 4. Discharge of the lower part of the engine cooling and cooler air cooler [3]
The upper left "coupling bracket" is deformed at the height of the left head by pushing it backward, towards the middle of the engine compartment MERCEDESA, by acting force in the direction from the front left corner to the rear right corner of the MERCEDES, Figure 5. Damage to the

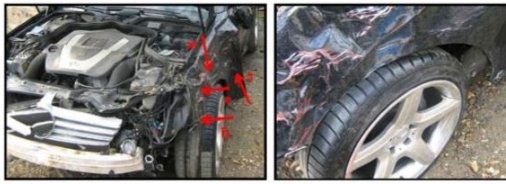
MERCEDESA on the front left mud track like scratch marks and traces of reddish traces, Figure 6. and 7.

Figure 5. detailed damage left fender [3]

Figure 6. Only damage to the left front fender [3]

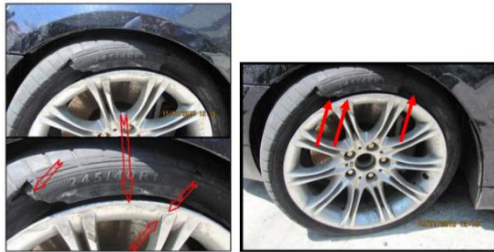
The analyzed traffic accident in this example occurred with injured persons, in which two passenger cars, brands BMW and HYUNDAI participated. Based on a detailed analysis of the material elements from the file, and in particular photographs from photo documentation and photographs of damage to BMW, it was found that the left side of the front left wheel tire was damaged in the form of a "split". On the rim and a spider of the front

left-hand mark, traces are like "dark-colored" marks, approximately at the height of the left-hand wheel left-hand tire damage, figure 11. BMW's damage is also on the back of the plastic part (below front left mudguard) separated from the front left mudguard and moved to the front of BMW, Figure 12.

Figure 11. and Figure 12. Damage to the tire - "splitting" [3]

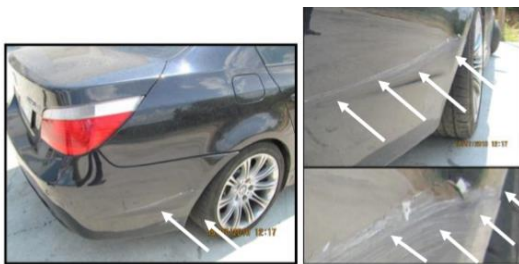
On the right-hand side of the BMW's rear bumper, the traces are like scratches, Figure 13. In the upper part of the damage to the right part of the BMW's rear bumper, there are "cracks", Figure 14.

Figure 13. and Figure 14. Scratches on the rear bumper and cracks on the right-hand side of the rear bumper [3]

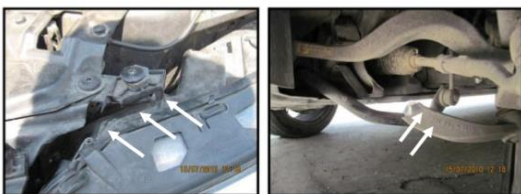
The right front left-hand holder is "interrupted" and the front left is not in the tray, Figure 15. The front left shoulder is "interrupted", Figure 16.

Figure 15. and Figure 16. Display of the right holder of the left head and left lower shoulder [3]

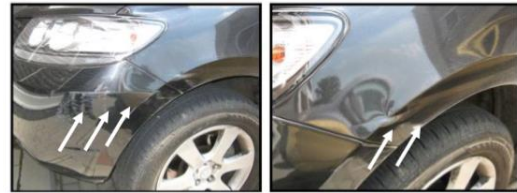
By analyzing the damage photos of HYUNDAI, damage to the front bumper (at the height of the front left-hand corner of HYUNDAI) was determined by the force of the front to the rear of HYUNDAI, Figure 17. The front left mudguard of HYUNDAI was damaged (at the height of the front part of the mudguard) by acting force from the front to the rear of HYUNDAI. Analyzing damage to the front of the front left mudguard of HYUNDAI on damage is the scratch trace, Figure 18.

Figure 17 and Figure 18. Display of front bumper damage and scratch marks [3]

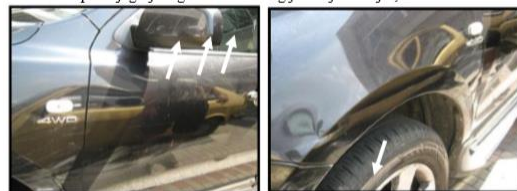
On the left side of the left side mirror of the HYUNDAI, traces are like traces of scratches and traces of blue, in the front left door, at the height of the middle of the door (viewed in length) and in the lower half of the door, it is visible damage in the form of "scratch" ', Figure 19. On the lower edge of the "edge" of the front left mudguard, the trail is "bright colors", Figure 20.

Figure 19. and Figure 20. Display of left-hand side mirror damage and "bright" color trace [3]

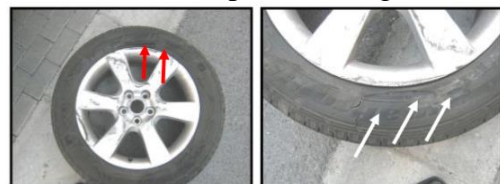
On the rim and the vapor, there are traces of "dark color", figure 21. The left side of the tire with traces of "dark color" is damaged in the form of a "split" tire, Figure 22.

Figure 21 and Figure 22. Tire damage display [3]

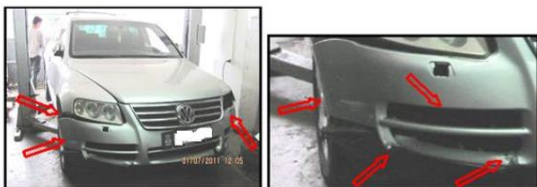
A detailed and comparative analysis of TOUAREG damage images found that the TOUAREG front bumper was deformed by the action of the force in the direction from the front to the rear of the TOUAREG, with the center of impact at the height of the front left corner. On the TOUAREG front bumper, about 0.4 m to the right of the left side of the TOUAREG, the damage is similar to the "tear" of the front bumper TOUAREG, Figures 23 and 24.

Figure 23. and Figure 24. Damage to the front bumper and "tear" of the front bumper [3]

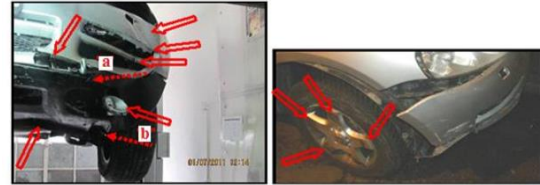
The decorative plastic on the lower part of the front bumper TOUAREG was damaged in the form of a "crack". At about 0.4 m (estimated from TOUAREG damage photos) to the right of the left side of the TOUAREG, the damage is "crack", the position "a" in Figure 25. At about 0.2 m

(estimated from TOUAREG damage images to the right of the left side of the TOUAREG, the damage is "crack", the "b" position in Figure 26. The front left TOUAREG fog is damaged by the glass front left fog lamp "broken" and not in the tray, Figure 25.

Figure 25. and Figure 26. Characteristic damage of decorative plastic and Damage to the front left wheel wheel [3]

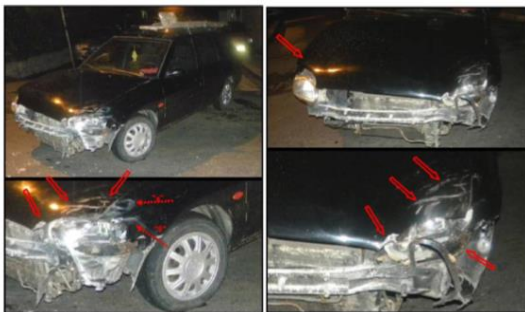
Detailed analysis of photographs from photo documentation found damage to FORD's front left mudguard in the form of deformation of sheet metal caused by the action of force in different directions, with a center of impact in several different places, Figure 29. The front edge of the front left mudguard FORD is at about 0.7 m above the surface (estimated from photographs from photo documentation) deformed by force acting roughly, in the direction from the upper front of the front left mud to the lower middle part of the FORD, the position "a" in figure 30. The

front edge of the front left mudguard FORD -a is approximately 0.6 m above the surface (estimated from photographic photo documentation) deformed by force acting approximately, in the direction from the front of the front left mud to the rear of the front right mudguard, the position " b " in figure 30. Na the front left part of the bonnet of the FORD motor vehicle, and at the height of the front left corners of the trail are like scratch marks. The front edge of the FORD bonnet cover at about 0.5 m to the right of the left side of the FORD is damaged by the front of the bonnet of the bonnet of the bonnet being pushed to the FORD engine compartment. The FORD bonnet cover is not located in the tray, figure 30. FORD's front left-hand mirror is broken and the front left of FORD is not in the tray. The front bumper and the front decorative mask of FORD, figure 30, are missing.

Figure 29. and Figure 30. Widely looks at the damage to the front left mudguard and shows a closer look at the damage to the front left mudguard [3]

In this example, based on detailed and comparative analysis of damage to TOUAREG and FORD, it was found that damage to the front right corner of the TOUAREG and front left-hand corner of FORD did not correspond to the collision of the front right corner of the TOUAREG and the front left-hand corner of the FORD- as described in the analyzed documentation. Also, based on a detailed and comparative analysis of material evidence from the analyzed documentation, it has been found that the traces of this traffic accident (listed in the inspection documentation) do not correspond to the traces that should result from the collision of the front right corner of the TOUAREG and front left corner of
