APPLICATION OF NOISE PROTECTION WALLS ALONG ROAD "A" TRANSVERSAL IN SARAJEVO

Review article

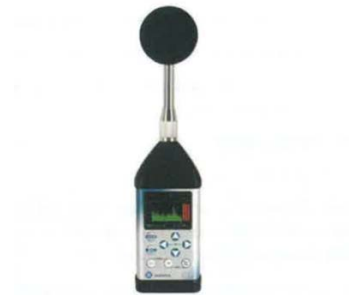
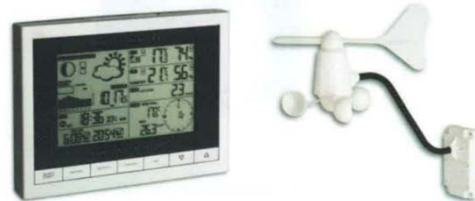
Uređaj za mjerenje i analizu buke, model SVAN 977

Slika 2.2. Kalibrator, model SV 33

Slika 2.3. Meteorološka stanica "Sinus"

Image 3. Noise measurement device, calibrator, and meteorological station

The noise measurements were performed using an SVAN 977 noise measurement device from the Polish manufacturer SVANTEK, with a calibrator model SV 33, and a TFA meteorological station of the

SINUS type. Data processing software used included SvanPC++3.3.26 and Supervisor 1.7.13. The devices are depicted in Image 3.

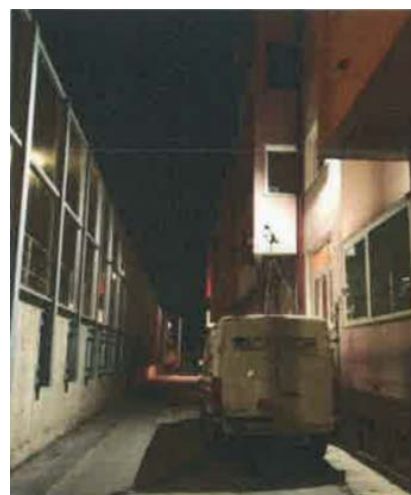
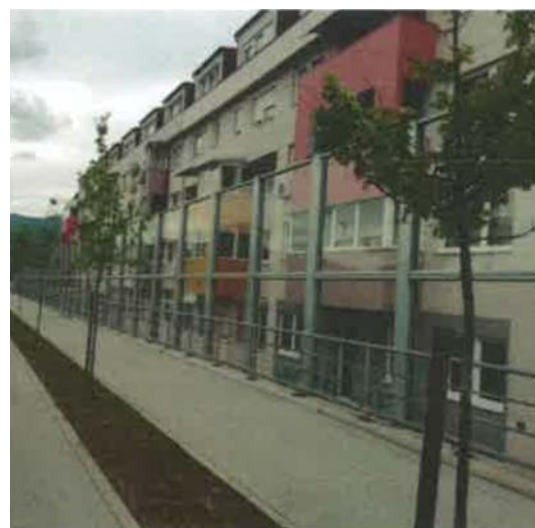
*Image 4.
Depiction of
measurement
point MP1*

Measurement point MP1 is located west of the roadway, in the immediate vicinity of a residential building on Hajrudina Šabanije Street. The measurement location is between the building and the sound barrier. The distance from the facade at the measurement site is 1.8 meters. The location of the measurement point is shown in Image 4, while Images 5 and 6 depict the measurement point and the noise protection wall.

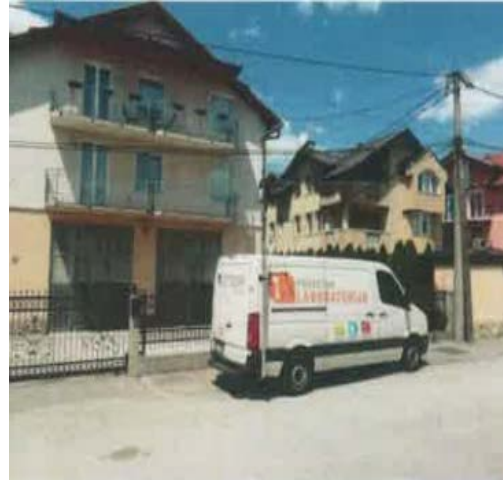
Image 8. Depiction of measurement point MP2

Measurement point MP2 is located on Branislava Nušića Street on the west side of the A highway, next to the fence of a residential building. The location of the measurement point is shown in Image 9, while Images 10 and 11 depict the measurement point and the noise protection wall.

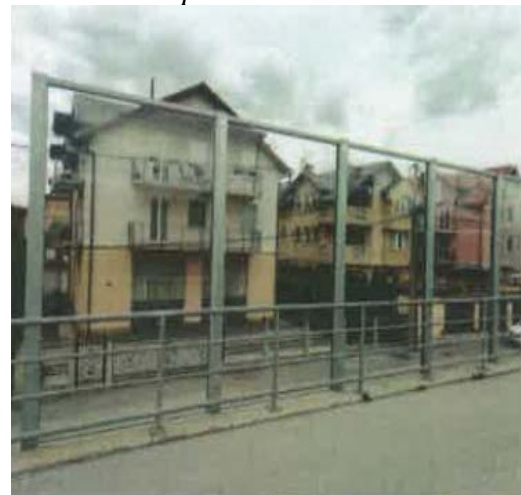
Image 9. Depiction of the sound barrier at MP2

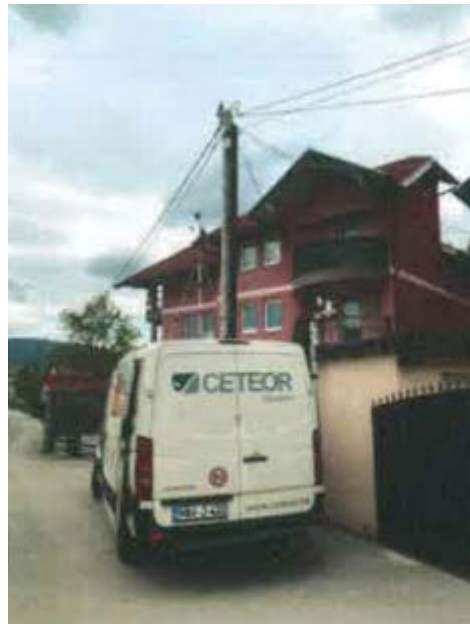
Image 12. Depiction of measurement point MP3

Measurement point MP3 is located on Branislava Nušića Street on the west side of the A highway, next to the fence of a residential building. The distance from the sound barrier at the measurement site is 6.0 meters. The location of the measurement point is shown in Image 14, while Images 15 and 16 depict the measurement point and the noise protection wall.

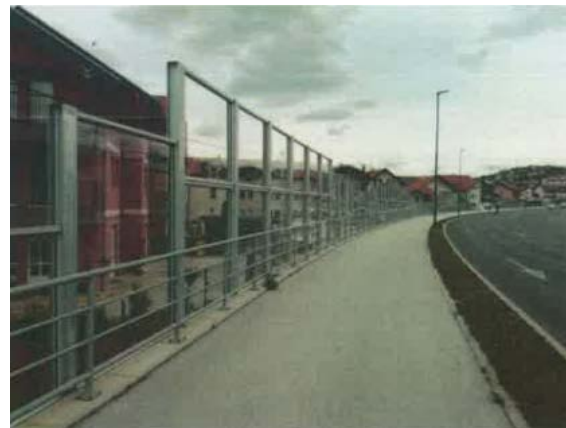
Image 13. Depiction of the sound barrier at MP3

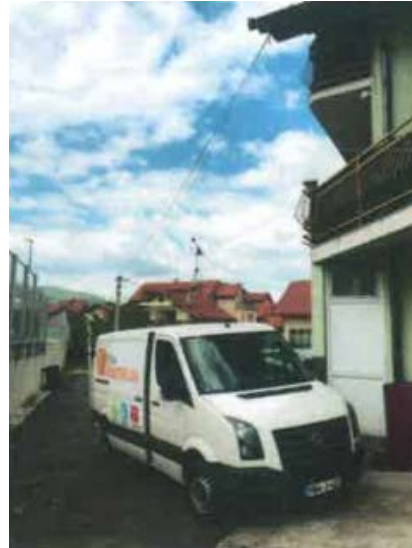
Image 16. Depiction of measurement point MP4

Measurement point MP4 is located on Ramiza Salčina Street in the immediate vicinity of a residential building. The distance from the sound barrier at the measurement site is 4.0 meters. The location of the measurement point is shown in Image 20, while Images 21 and 22 depict the measurement point and the noise protection wall.

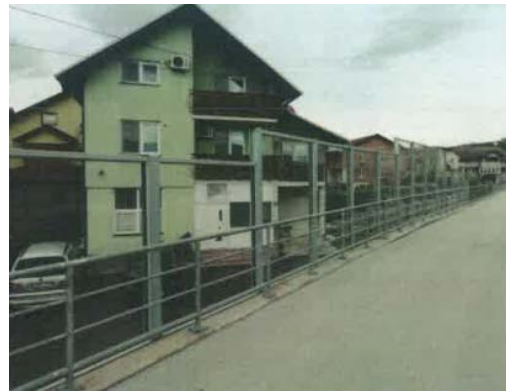
Image 17. Depiction of the sound barrier at MP4

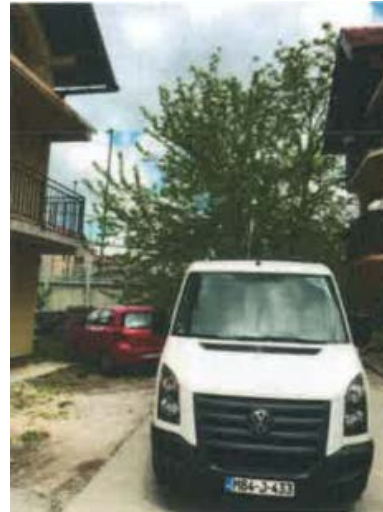
Image 20. Depiction of measurement point MP5

Measurement point MP5 is located on Branislava Nušića Street, on the eastern side of the A transferzale. The distance from the sound barrier at the measurement site is 12.0 meters. The depiction of the measurement point location is shown in Image 24, while Images 25 and 26 depict the measurement point and the noise protection wall.

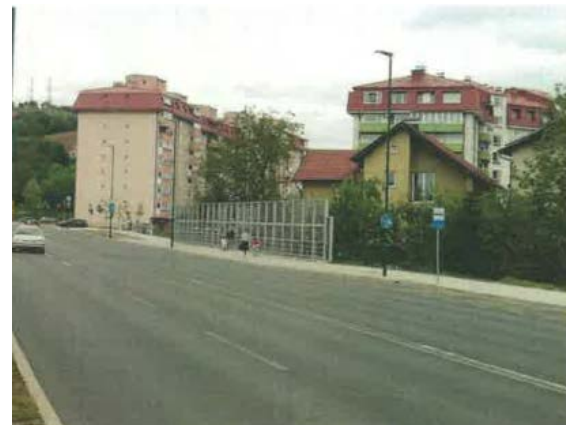
Image 21. Depiction of the sound barrier at MP5
